Contents – Technical Appendices

SEI Technical Appendix 3.1: Outline Construction Environmental Management Plan (CEMP)

Uisenis Wind Farm

Uisenis Power Limited

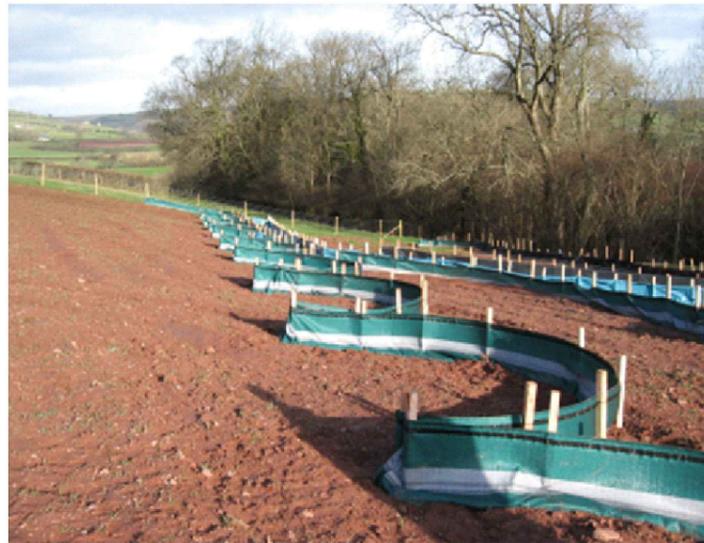
EXAMPLE OF INSTALLED SILT FENCING

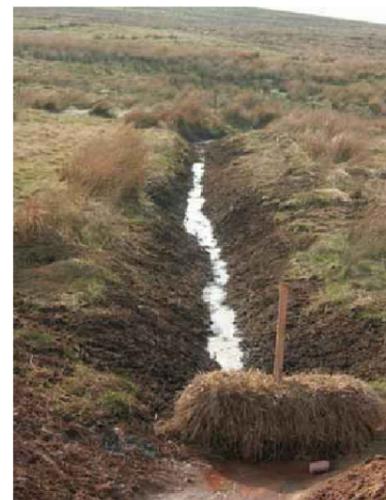
STRAW BALE TEMPORARY SILT TRAP
(FROM WIND FARM CONSTRUCTION GOOD PRACTICE GUIDE)

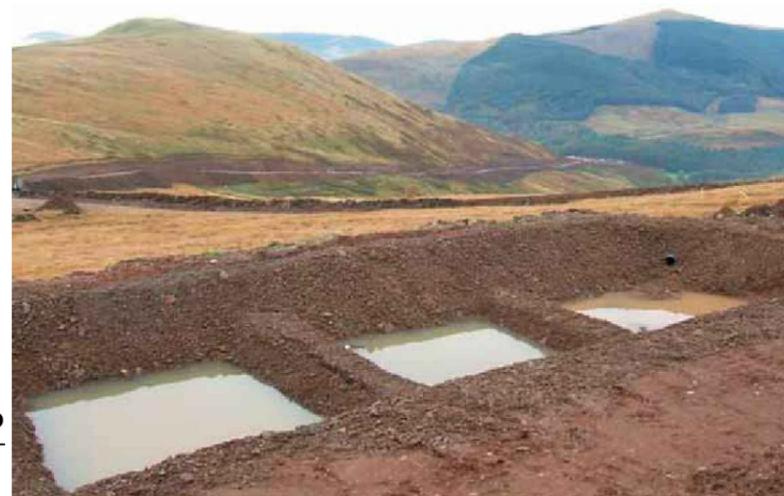
EXAMPLE OF CONSTRUCTED IN-LINE SILT TRAPS
(FROM WIND FARM CONSTRUCTION GOOD PRACTICE GUIDE)

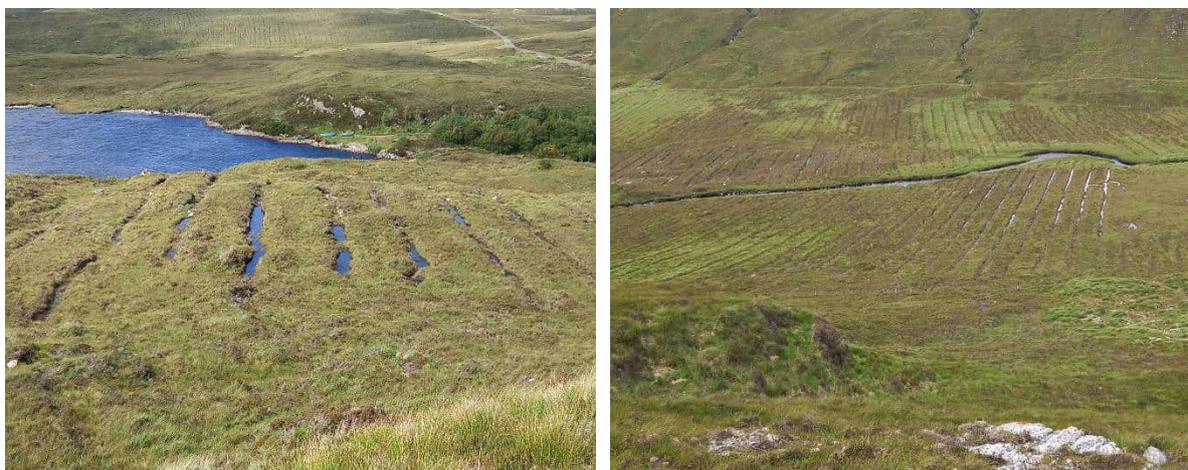
Photograph 5-1
Blanket bog area with drainage ditches suitable for blanket bog restoration

There are several areas of degraded blanket bog on Site that have drains dug through the peat. This type of drainage exposes the bare peat for drying and erosion and lowers the water table, thereby degrading the peatland (see **Photograph 5-1**). There are five areas outlined to be targeted for blanket bog restoration, covering 89ha in total, including several areas close to the north of Eishken Lodge, and an area along the waterway that connects Loch na Beirighe and Loch Eishken (see **SEI Figure 8.5.1 and 8.5.3**). Other blanket bog areas within the Site are in good condition with a high water table and good species diversity with presence of blanket bog indicator species, and are therefore not suitable for restoration (**SEI Figure 8.5.2**).

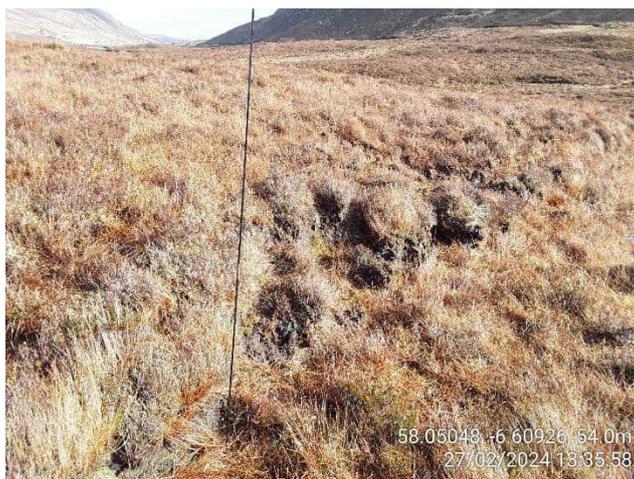
Photograph 5-2
Peat cutting areas suitable for blanket bog restoration

Additional areas of peat cutting were recorded in the north west of the Site to the south east of Loch Shiphoint. Peat cutting has taken place in narrow strips 2m to 3m wide, where generally strips have been cut with an uncut baulk (also 2m to 3m wide) left in between. There is also evidence of strip cutting within a grassland suggesting that this area was created through the removal of peat (**Photograph 5-2**). This area is heavily grazed by sheep, and the high grazing pressure extends to the surrounding areas of peatland habitat. Many of the faces have eroded to a moderate or gentle slope, however 50%+ may be suitable for re-profiling works. There are also two areas where parallel drains are present on blanket bog, with no strip cutting. This may be the precursor to peat cutting works.

Ditch blocking and re-profiling the faces of the strip cutting areas are likely to be the best management technique for restoring these areas, however given the extent of the drainage, the areas should be assessed in detail during preparation of the detailed HMP and other restoration techniques should also be considered, such as wave damming and ground smoothing. This assessment would be underpinned by assessments carried out previously on this Site in a previous HMP (Arcus Renewable Energy Consulting Ltd., 2012), however due to developments in peatland restoration methods in recent years, a full blanket bog restoration assessment would be undertaken across all five areas and the best techniques recommended.

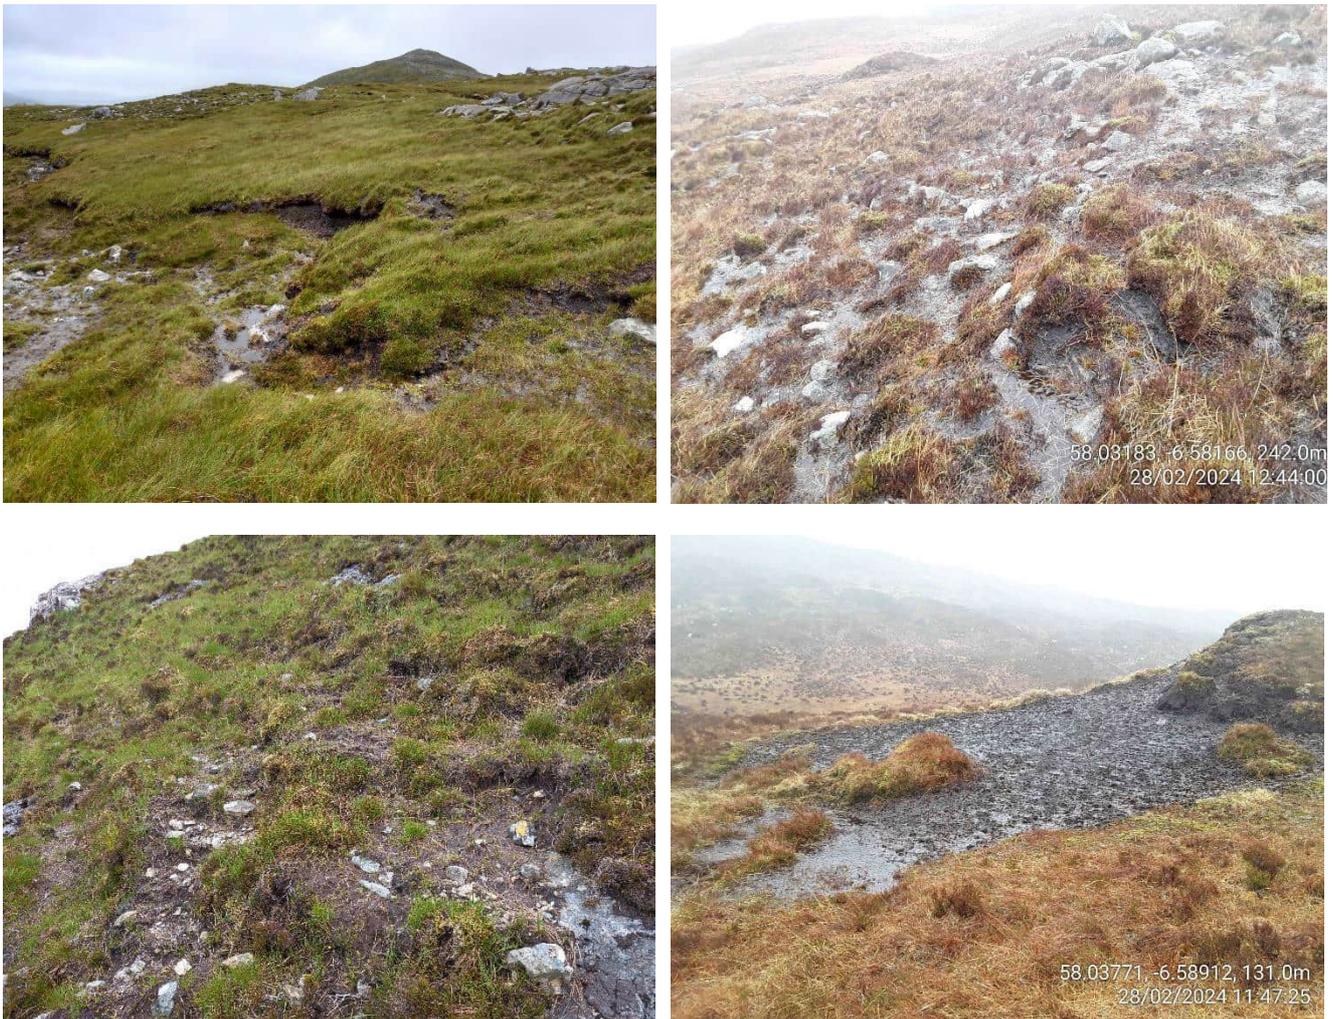
Photograph 5-3
Areas of erosion within wet heath areas suitable for habitat restoration

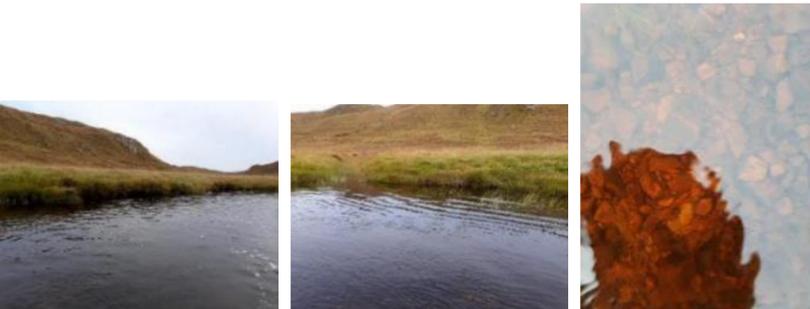
An 85 m stretch of the Abhainn Cheothadail with Unsuitable habitat due to lack of boulders in the substrate for shelter and stabilisation (10% gravel, 60% pebble and 30% cobble). Substrate changes to hard compacted cobbles and pebbles with soft mud/clay and areas of vegetation (20%) at the edges. A small, shallow (<0.25 m) watercourse enters on the left bank with mud/clay substrate (100%) which is also unsuitable for FWPM. Bankside vegetation and land use was the same as previous Survey Locations. There are two target notes (Appendix C) within this Survey Location. An area of algal blanket which covers more than 80% of the riverbed, which is highlighted as a eutrophication limitation for FWPM, in Table 2. Target notes available to view in Appendix D.

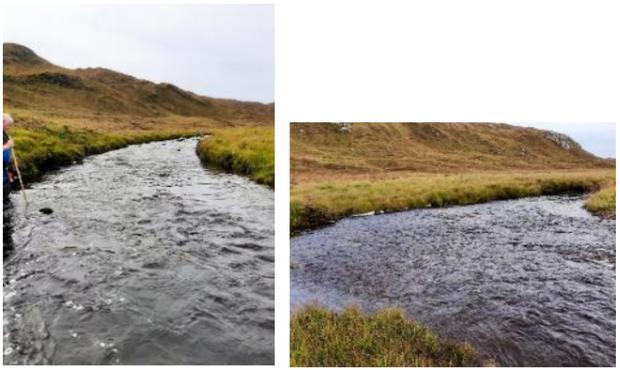
Survey Location	Photograph of Survey Location and/or Substrate	Description
SL_5

<p>An 87 m stretch of the Abhainn Cheothadail that is Unsuitable habitat for FWPM due to limited fines / no gravel present in the substrate, which is required for FWPM stabilisation. Substrate consisted of 50% pebble, 40% cobble, 10% boulder. Average depth is 0.7 m. Average wet width is 3.5 m, with one wider section (15 m wet width, 20 m length, 0.25 m depth) present within the section. The wide section has similar substrate but with only 5% boulders. The collapsed left peat banks described in previous section, continue in this section. Bankside vegetation and land use is the same as previous Survey Locations. Photographs show an upstream view of the Survey Location, and a particularly wide section of the river.</p>
SL_6

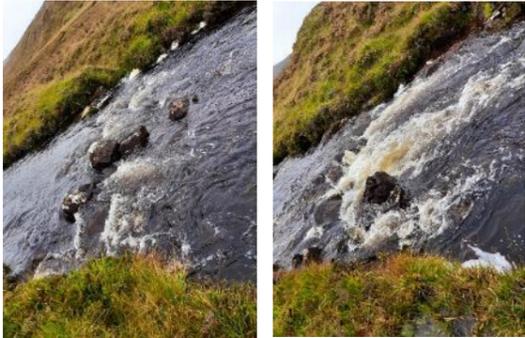
SL_7

<p>An Unsuitable 60 m section of the Abhainn Cheothadail due to bedrock and shallow, fast flowing water. Substrate consisted of 10% gravel, 20% pebble, 40% cobble, 10% boulder, 20% bedrock. Areas of fast flow made entry to this section inaccessible for surveyors in places. Areas of torrents and high flows are subject to higher bed transport which is unsuitable for FWPM. It was reasoned if it was unsafe for entry, then flows would be unsuitable for FWPM. Average wet width was 11 m, average depth was 0.25 m. Bankside vegetation and land use was the same as previous Survey Locations.</p>
SL_8

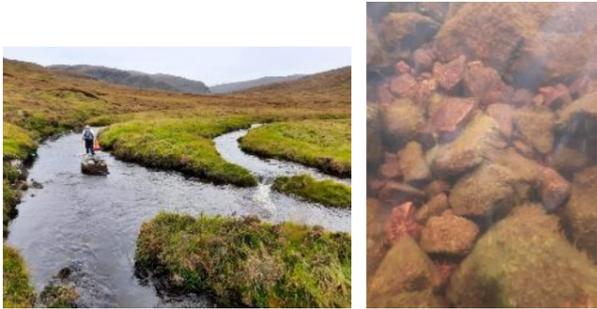
<p>A 150 m (total including river split) stretch of the Abhainn Cheothadail of Unsuitable habitat due to unsuitable substrate (bedrock with lack of boulders), and algal growth. The river splits into 2 channels in this section.</p> <p>The left channel consists of initially bedrock for 10 m and progresses to 20% gravel, 30% pebble, 40% cobble, and 10% boulder. Flow rate was lower than the previous section and water was shallower (0.2 m average depth) in the left channel.</p> <p>The right channel had some sub-optimal habitat but a distinct lack of boulders with cobbles too small to provide suitable cover (20% gravel, 30% pebble and 50% cobble). Average wet width of the right channel was 2 m and average depth was 0.6 m, flow was similar to the left channel.</p>

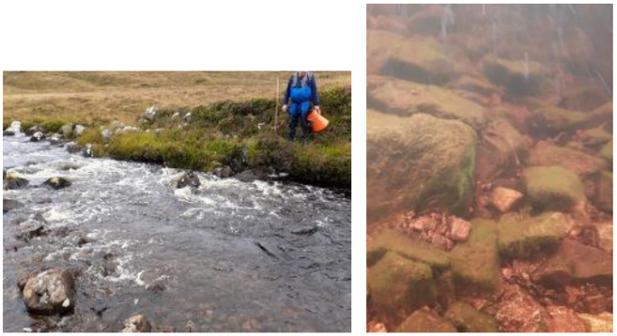
<p>A 270 m stretch of the Abhainn Cheothadail of Unsuitable habitat due to high flow run, riffle and torrents. Limitations to survey were present with some areas unsafe to enter for surveyors due to fast flows. It was reasoned if it was unsafe for entry, then flows would be unsuitable for FWPM with bed transport at these areas high. Pockets of suitable habitat and bedrock were noted as target notes (Appendix C). Water Quality was also taken at the end of the section. Substrate consisted of 10% gravel, 10% pebble, 60% cobble, 20% boulder. Average wet width 12 m, average depth was shallow at 0.3 m. Bankside vegetation and land use was the same as previous Survey Locations.</p>
SL_10

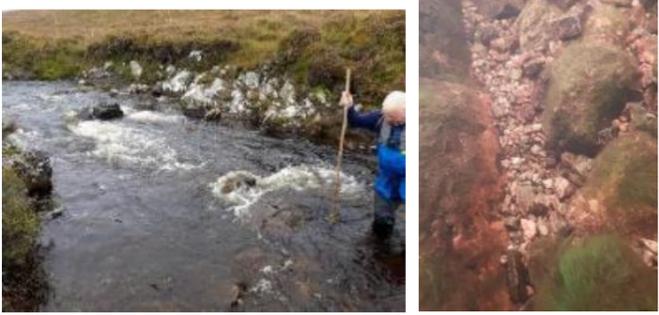
<p>A 32 m stretch of the Abhainn Cheothadail of Unsuitable FWPM habitat, with sheets of bedrock lining the banksides and substrate in some areas, and areas of high torrent flows. Limitations to survey were present where it was unsafe to enter to some areas due to fast flows. It was reasoned if it was unsafe for entry, then flows would be unsuitable for FWPM and bed transport at these areas would be too high. Narrows from 12 m in previous section, to 3.5 m in this section. Pockets of higher vegetation/algal blanket, and soft peat base also present within this survey location. Substrate consisted of 10% gravel, 30% pebble, 50% cobble, 10% boulder. Some Sub-Optimal pockets of substrate were present but no FWPM were present. Bankside vegetation and land use was the same as previous Survey Locations.</p>

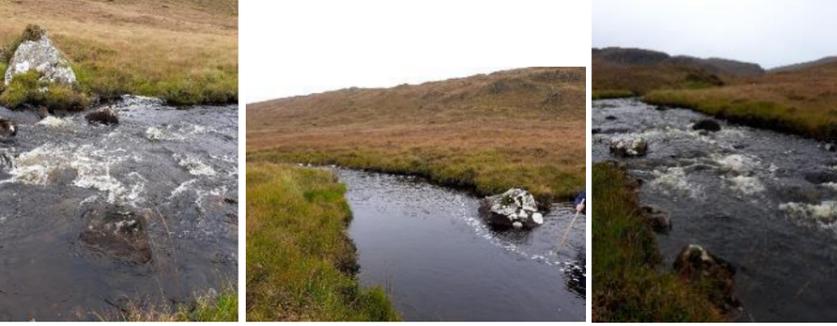
SL_11

<p>A 154 m stretch of the Abhainn Cheothadail of Sub-Optimal habitat. Substrate consisted of 10% gravel, 20% pebble, 40% cobble, 25% boulder, 5% bedrock. The river here had an average depth of 0.35 m but fast flows with riffle, run and torrent areas throughout. Limitations to survey were present as it was unsafe to enter the water at some points throughout this Survey Location due to fast flows. It was reasoned if it was unsafe for entry, then flows would be unsuitable for FWPM and bed transport at these areas would be too high. Average wet width increases to 9 m here. Bankside vegetation and land use was the same as previous Survey Locations.</p>
SL_12

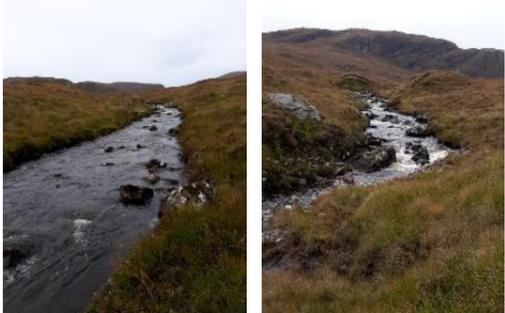
<p>An 85 m stretch of the Abhainn Cheothadail of Unsuitable FWPM habitat. The river here had an average depth of 0.6 m, and fast flowing with bedrock, and torrent and riffle/run sections throughout. Limitations to survey were present as it was unsafe for surveyors to enter due to fast flows. It was reasoned if it was unsafe for entry, then flows would be unsuitable for FWPM and bed transport at these areas would be too high. Average wet width was 6 m. Substrate consisted of 10% pebble, 20% cobble, 30% boulders, and 40% bedrock. Bankside vegetation and land use was the same as previous Survey Locations.</p>

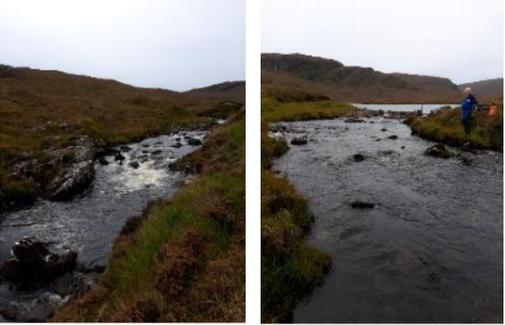
<p>A 365 m stretch of the Abhainn Cheothadail of Unsuitable FWPM habitat due to Unsuitable substrate and high flows. Multiple deep pockets where torrents and boulder dams are throughout meant that the average depth was 0.8 m. Some of these locations were unsafe to enter due to fast flows. It was reasoned if it was unsafe for entry, then flows would be unsuitable for FWPM and bed transport at these areas would be too high to sustain FWPM populations. Average wet width was 4.5 m. Substrate consisted of 10% pebble, 20% cobble, 30% boulders, and 40% bedrock. Bankside vegetation and land use was the same as previous Survey Locations.</p>
SL_14

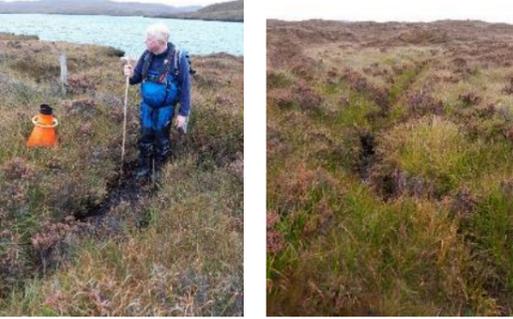
<p>A small watercourse entering Loch Eishken. Unsuitable FWPM habitat with insufficient flow and depth to sustain FWPM populations. The watercourse narrows further upstream. Depth was <0.1 m and wet width 1m average. Overhanging bankside vegetation makes the watercourse mostly overgrown.</p>

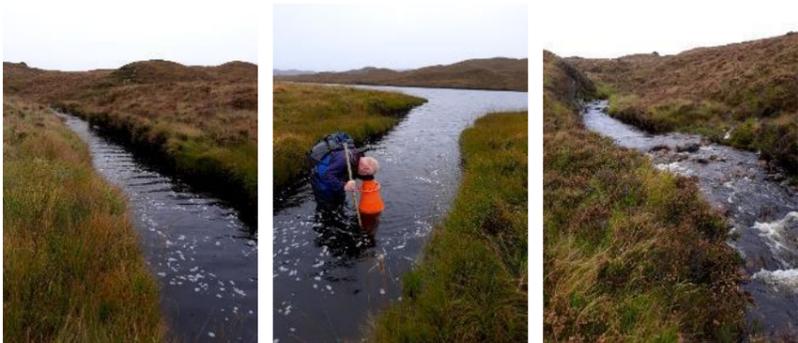
<p>An unnamed watercourse entering Loch Eishken with Sub-Optimal FWPM habitat, with FWPM requirements being out-with Optimal range – but still within liveable requirements for substrate, environmental conditions, and water quality. Substrate consisted of 10% gravel, 20% pebble, 40% cobble, 25% boulder and 5% bedrock. There was approximately 5% instream vegetation on substrate. The wet width was 2.5 m average and depth was 0.7 m average. Watercourse banksides consisted of peat banks. Water quality was taken at this Survey Location.</p>
SL_18

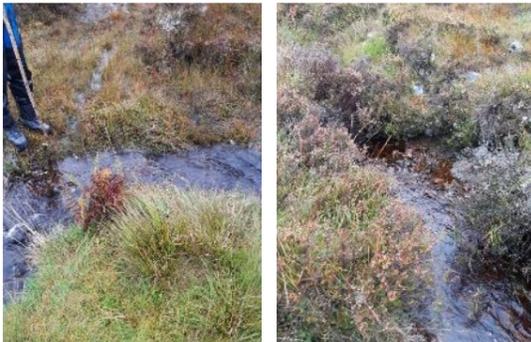
SL_19

<p>An unnamed watercourse entering Loch Eishken. Unsuitable FWPM habitat due to insufficient flow and shallow water levels out-with FWPM requirements (Table 2). Narrow in wet width (<0.5 m) and shallow in depth (<0.2 m). Insufficient flow to sustain FWPM.</p>
SL_20

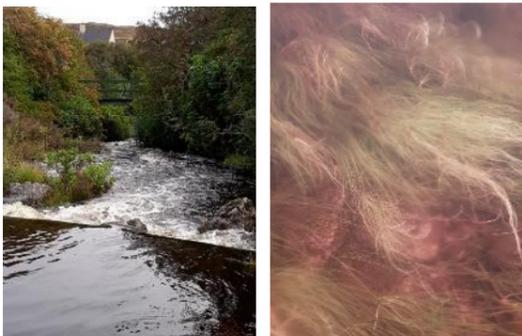
<p>River Eishken swell/Eishken Lodge Pond margins surveyed for suitable habitat further downstream at dam. Limitations to survey were present as it was unsafe to enter and survey at some points throughout this Survey Location due to depth being >2 m. Substrate consisted of 20% silt/sand, 10% pebble, 10% cobble, 20% boulder, and 40% mud, with high (>80%) instream vegetation / algae covering the substrate. Sub-Optimal FWPM habitat, as per Table 2 requirements. The algal blanket was recorded as a target note for an area of potential eutrophication. Target notes can be viewed in Appendix D.</p>

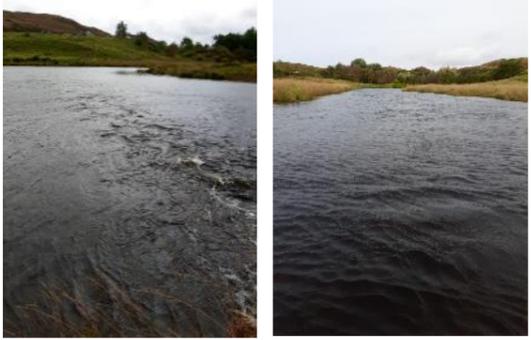
<p>River Eishken swell into Eishken Lodge Pond featuring Sub-Optimal habitat for FWPM. Shallow at the edges, and then too deep (>2 m) to enter. Substrate was within Optimal requirements (10% gravel, 40% pebble, 40% cobble, 10% boulder), but high vegetation/algal presence on the substrate (>80%). The algal blanket was recorded as a target note for an area of potential eutrophication. Target notes can be viewed in Appendix D.</p>
SL_22

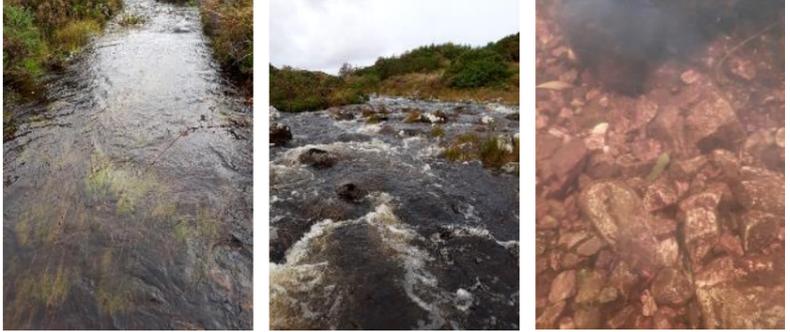
<p>Downstream of Loch Eishken to Loch Sealg watercourse downstream of bridge. Unsuitable habitat, an island in the middle splits the river in two. Substrate overall 10% gravel, 10% pebble, 30% cobble, 50% boulder. But unsuitable due to high flows and high bed transport. Right channel narrower (<2 m wide), with lower flow (depth 0.3 m average), and areas of high vegetation (~80%). Some terrestrial vegetation was submerged due to high flows. The left channel had some instream vegetation (~20%) but significantly faster flows and deeper water (depth 0.9 m average). This resulted in areas that could not be entered due to safety issues – again limitations to this Survey Location. Where safe, substrate was checked and approximately 60% of the area was accessible to be surveyed. Water Quality was taken here.</p>

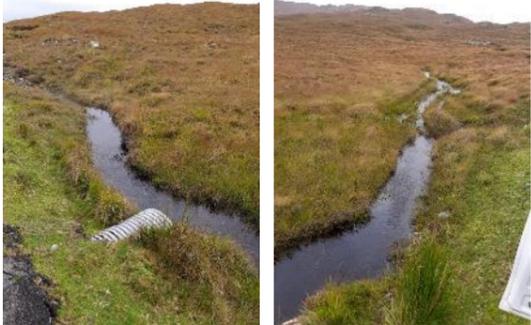
<p>Unsuitable FWPM habitat due to insufficient flow and depth (<0.2 m) in most areas. Average wet width was 0.7 m. 50 m above road bridge, and 50 m below bridge was surveyed.</p>

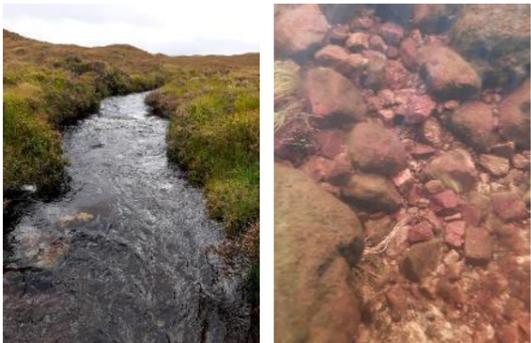
<p>A 62 m section of Abhainn Ghlas with Sub-Optimal habitat with FWPM requirements being out-with Optimal range – but still within liveable requirements for substrate, and environmental conditions. Water quality was below FWPM range for pH – but this could be due to high rainfall and run off in days immediately before sampling, hence the rating of Sub-Optimal. Average wet width was 1 m and average depth was 0.4 m. Substrate consisted of 20% gravel, 30% pebble, 30% cobble and 10% boulder. Flow rate was optimal and undercut bank provided cover at this Survey Location.</p>
SL_26

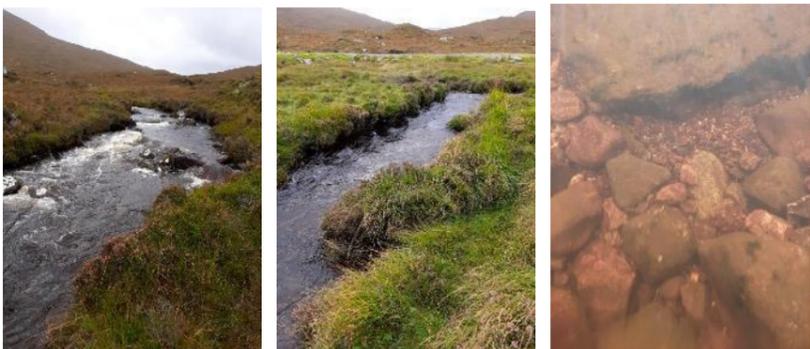
<p>A 50 m stretch of a Seaforth River Tributary surveyed above and below the road bridge crossing. Upstream of the bridge featured unsuitable habitat for FWPM due to bedrock and torrent areas. Limitations to survey were present as it was unsafe for surveyors to enter due to fast flows. It was reasoned if it was unsafe for entry, then flows would be unsuitable for FWPM and bed transport at these areas would be too high. Downstream of the road bridge featured Sub-Optimal habitat for FWPM due to a change in flow and substrate however there was still a lack of larger stones and boulders which are required for stabilisation of substrate and shelter for FWPM. Average wet width was 1.8 m, average depth 0.4 m. Substrate downstream consisted of 20% gravel, 40% pebble, 35% cobble, 5% boulder. Water quality taken downstream.</p>

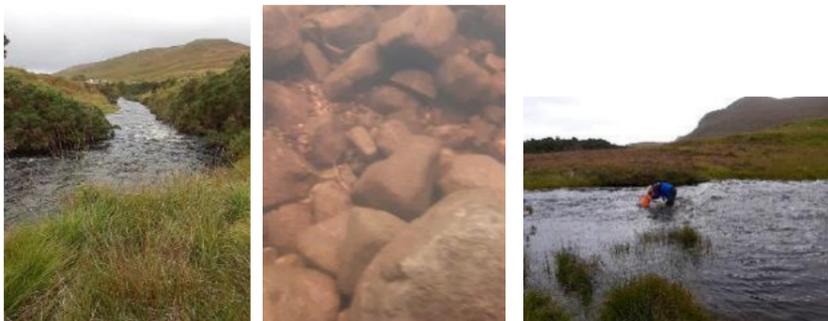
SL_27

<p>A 40 m stretch of the Seaforth River where Optimal FWPM habitat was found where the river widened. Average wet width was 9 m and average depth was 0.4 m. Substrate consisted of 20% gravel, 30% pebble, 30% cobble, 20% boulder, with Optimal pockets of FWPM habitat seen throughout. Below this 40 m stretch was extremely fast flowing water, with torrents and rapids making it too unsafe to enter and survey any further downstream.</p>
SL_28

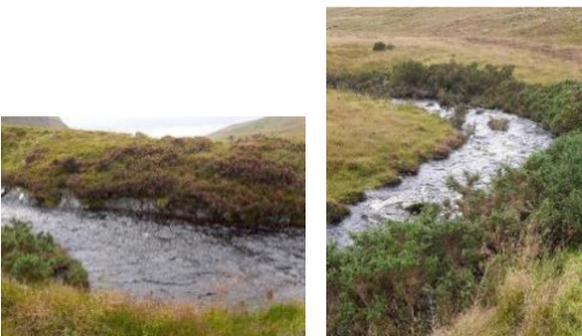
<p>A 220 m section of the Seaforth River with torrents and rapids throughout. Many sections were also very deep (>2 m). Limitations to survey were present as it was unsafe to enter and survey at some points throughout this Survey Location due to depth being >2 m, and very fast flowing water. It was reasoned if it was unsafe for entry due to high flows, then this would be unsuitable for FWPM as flow conditions would result in high bed transport and unstable substrate. A stable substrate to adhere themselves to, is a requirement for FWPM colonisation. More information on FWPM requirements can be viewed in Table 2.</p>

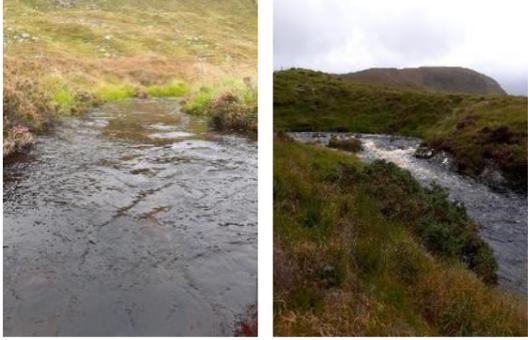
<p>A short 20 m section of the Seaforth River categorised as Sub-Optimal FWPM habitat. This watercourse was deep (>2 m) and fast flowing in several places. The substrate at this Survey Location consisted of 10% gravel, 20% pebble, 40% cobble and 30% boulder. Instream vegetation covered 50% of the substrate. The right channel average wet width was 3.5 m, and average depth was 1.5 m. Along the left bank was very deep and unsafe to enter, thus the right bank edges where accessible were surveyed. Water quality was taken here. Limitations to survey were present as it was unsafe to enter and survey at some points throughout this Survey Location due to depth being >2 m and flow conditions too fast to enter safely. It was reasoned if it was unsafe for entry due to high flows, then this would be unsuitable for FWPM as flow conditions would result in high bed transport and unstable substrate. A stable substrate to adhere themselves to, is a requirement for FWPM colonisation. More information on FWPM requirements can be viewed in Table 2.</p>

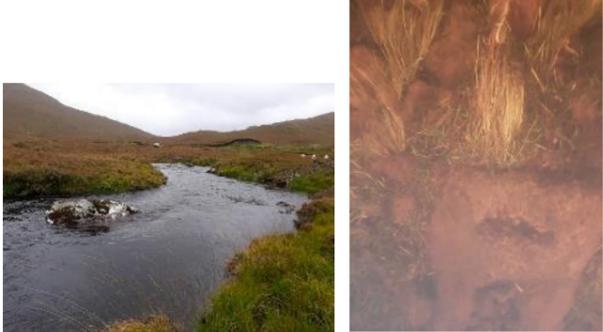
SL_30

<p>SL_30 consisted of a large section of the Seaforth River where the river splits into two channels. There was a mixture of Unsuitable and Sub-Optimal FWPM habitat in these sections, with the right channel mainly Unsuitable due to high flows. The left channel was mainly Sub-Optimal with a small section of torrents and high flows. The substrate at this Survey Location consisted of 10% gravel, 20% pebble, 40% cobble and 30% boulder. Instream vegetation coverage was 50%. Average wet width was 12 m, and average depth was 1.5 m. The left bank depth was >2 m and inaccessible. At the top of the Survey Location, torrents and fast flowing water made access unsafe with deep pools below. Limitations to survey were present as it was unsafe to enter and survey at some points throughout this Survey Location due to fast flows and depth being >2 m. It was reasoned if it was unsafe for entry due to high flows, then this would be unsuitable for FWPM as flow conditions would result in high bed transport and unstable substrate. More information on FWPM requirements can be viewed in Table 2.</p>

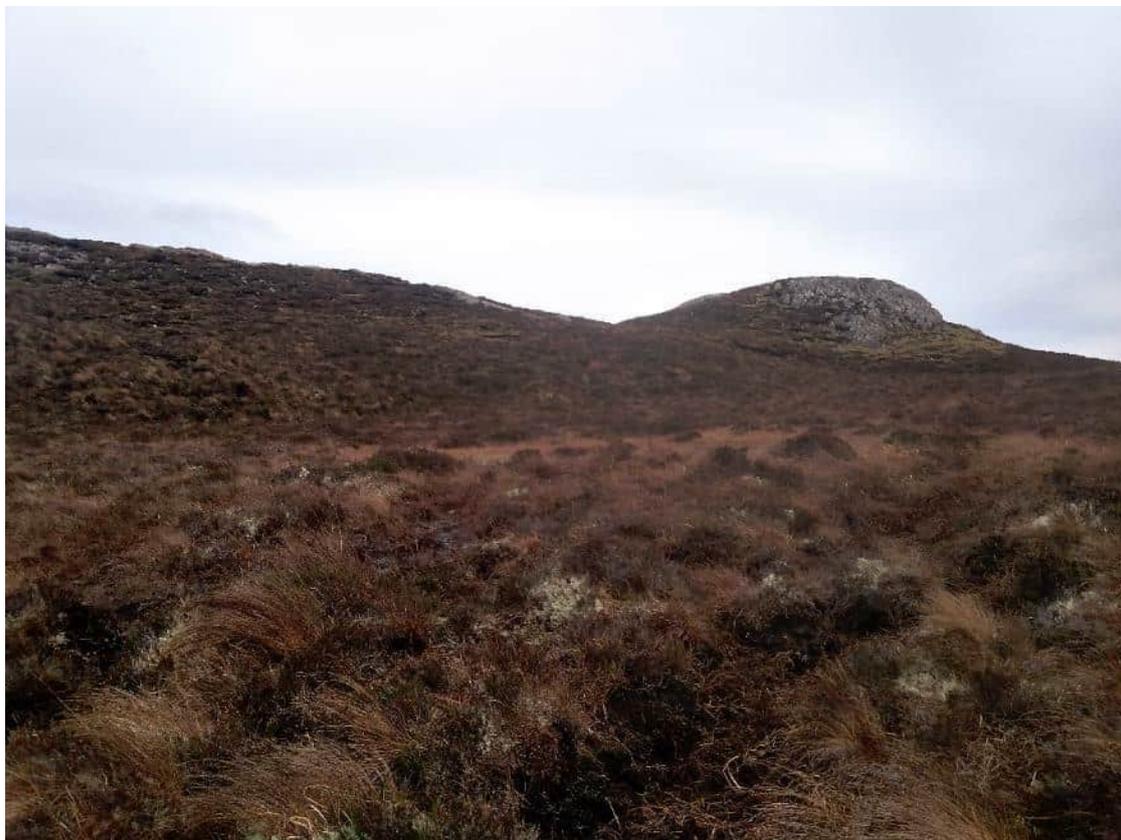
Photo 1: View looking east from NGR NB 32772 14351 showing BP1

Borrow Pit 1 (BP1) is proposed in the north east of the Site at approximately NGR NB 32831 14332 shown on **SEI Figure 10.3.4** with further details in **Table C**.

Borrow Pit Details	
Excavation Area	Approximately 6,592m ²
Height of Excavation	Approximately 7.2m
Gradient	Slope increasing gently towards the north
Details of Likely Extraction	Combination of digging, drilling and blasting
Likely Overburden Type and Depth	No detailed GI undertaken to date. No mapped superficial deposits. Average peat depth thickness 0.19m.
Extent of Aggregate Extraction	Approximately 36,817m ³
Aggregate Composition	Outer Hebrides Thrust Zone Mylonites Complex - Pseudotachylite

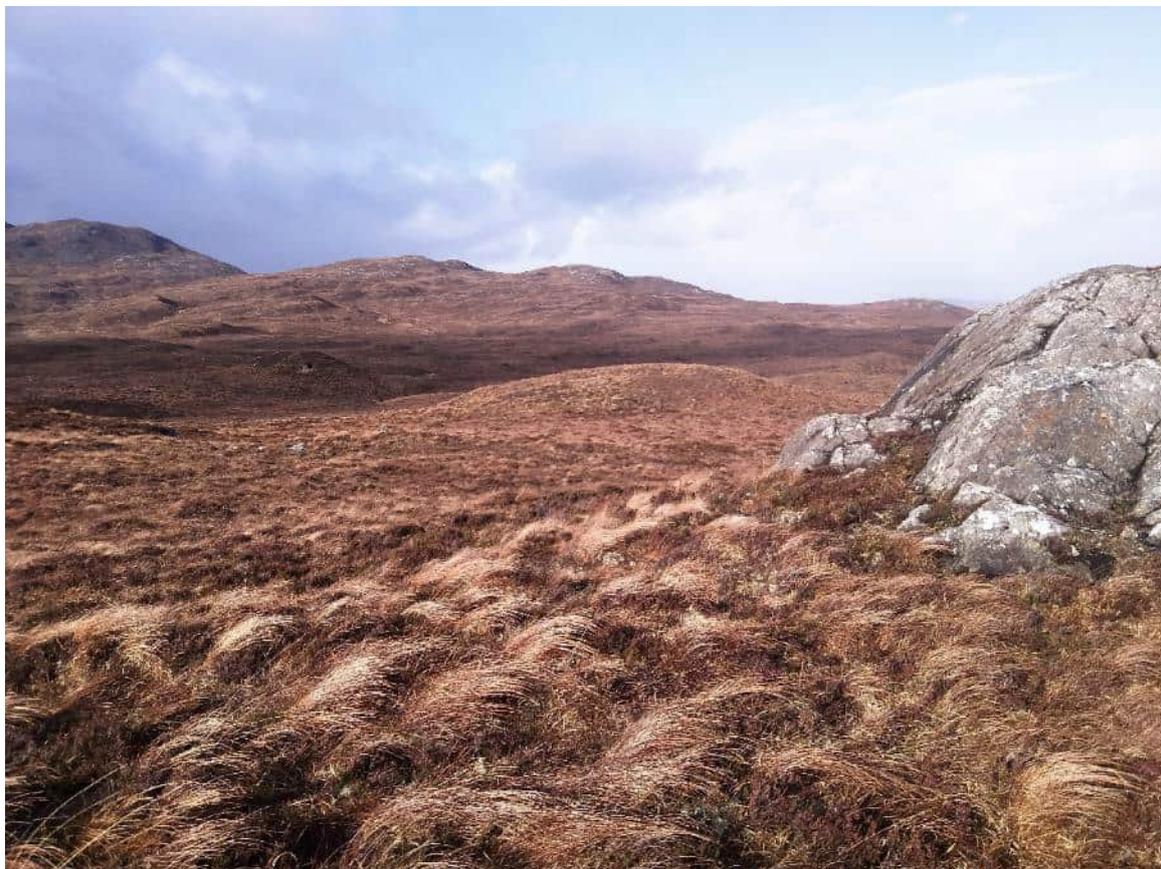
Photo 2: View looking north-west from NGR NB 31954 14083 showing BP2

Borrow Pit 2 (BP2) is proposed in the north east of the Site at approximately NGR NB 31917 14097 shown on **SEI Figure 10.3.5** with further details in **Table D**.

Borrow Pit Details	
Excavation Area	Approximately 4,008m ²
Height of Excavation	Approximately 10m
Gradient	Slope increasing gently towards the west
Details of Likely Extraction	Combination of digging, drilling and blasting
Likely Overburden Type and Depth	No detailed GI undertaken to date. No mapped superficial deposits. Average peat depth thickness 0.38m.
Extent of Aggregate Extraction	Approximately 16,721m ³
Aggregate Composition	Lewisian Complex - Amphibolite

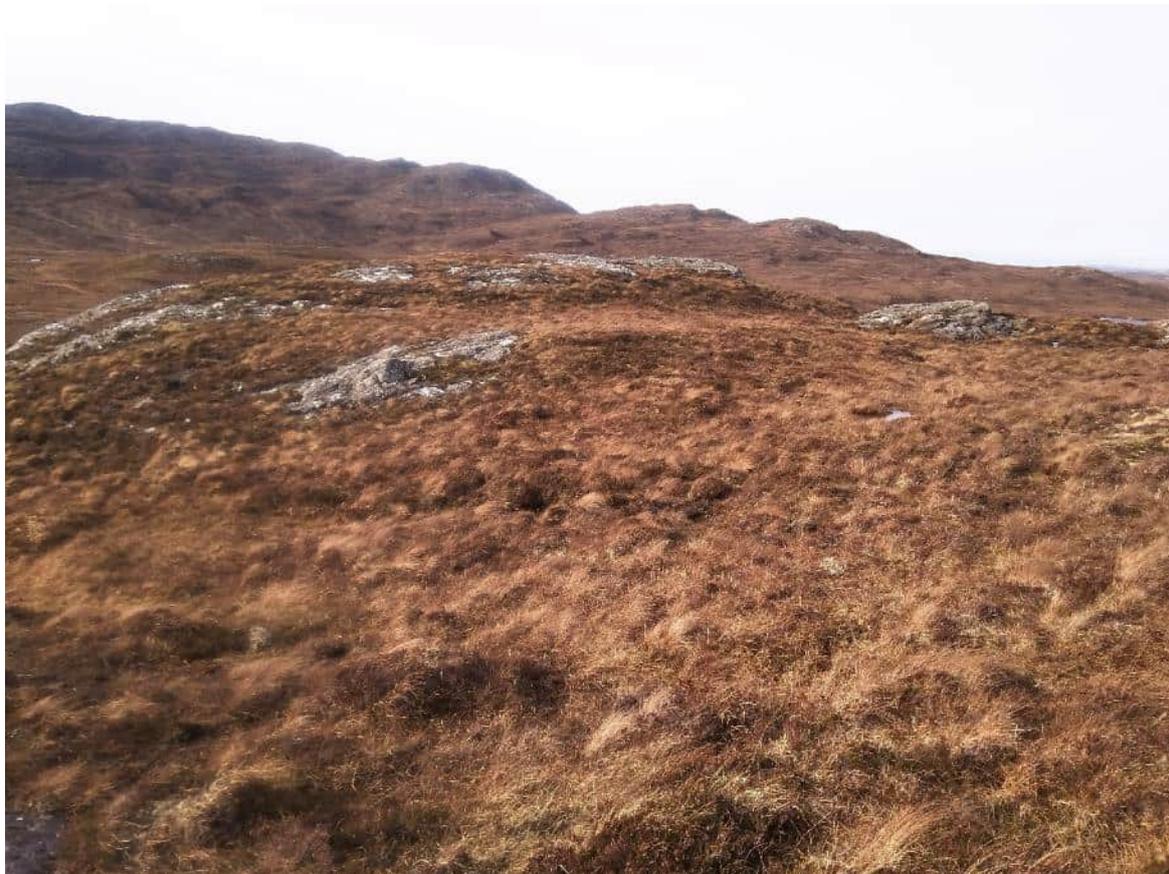
Photo 3: View looking northwest from NGR NB 32327 13846 showing BP3

Borrow Pit 3 (BP3) is proposed in the north east of the Site at approximately NGR NB 32338 13808 shown on **SEI Figure 10.3.6** with further details in **Table E**.

Borrow Pit Details	
Excavation Area	Approximately 16,172m ²
Height of Excavation	Approximately 13.6m
Gradient	Slope increasing gently towards the north
Details of Likely Extraction	Combination of digging, drilling and blasting
Likely Overburden Type and Depth	No detailed GI undertaken to date. No mapped superficial deposits. Average peat depth thickness 0.29m.
Extent of Aggregate Extraction	Approximately 84,836m ³
Aggregate Composition	Outer Hebrides Thrust Zone Mylonites Complex - Pseudotachylite Lewisian Complex - Amphibolite

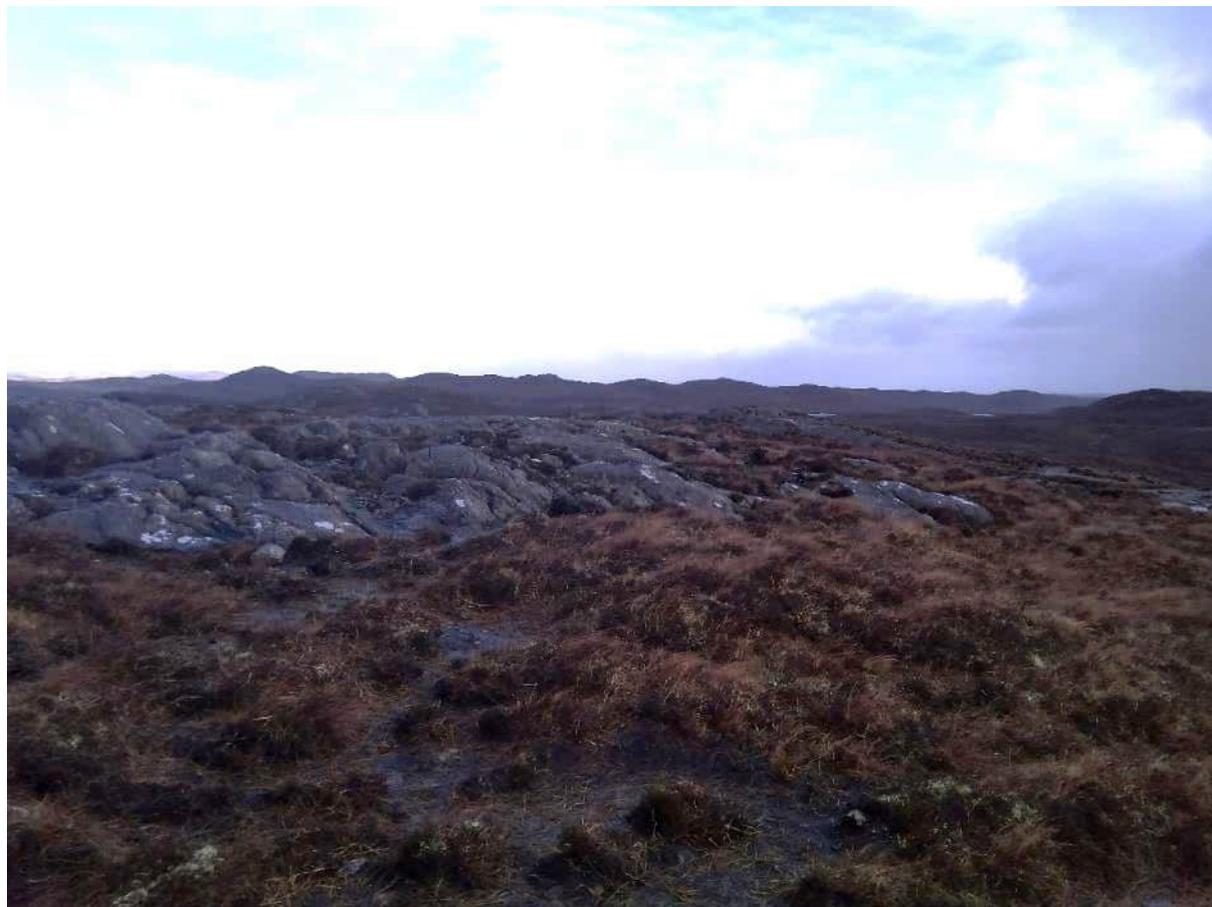
Photo 4: View looking west from NGR NB 32968 13308 showing BP4

Borrow Pit 4 (BP4) is proposed in the north east of the Site at approximately NGR NB 32949 13288 shown on **SEI Figure 10.3.7** with further details in **Table F**.

Borrow Pit Details	
Excavation Area	Approximately 3,348m ²
Height of Excavation	Approximately 6.2m
Gradient	Slope increasing gently towards the north-west
Details of Likely Extraction	Combination of digging, drilling and blasting
Likely Overburden Type and Depth	No detailed GI undertaken to date. No mapped superficial deposits. Average peat depth thickness 0.20m.
Extent of Aggregate Extraction	Approximately 9,655m ³
Aggregate Composition	Outer Hebrides Thrust Zone Mylonites Complex - Pseudotachylite

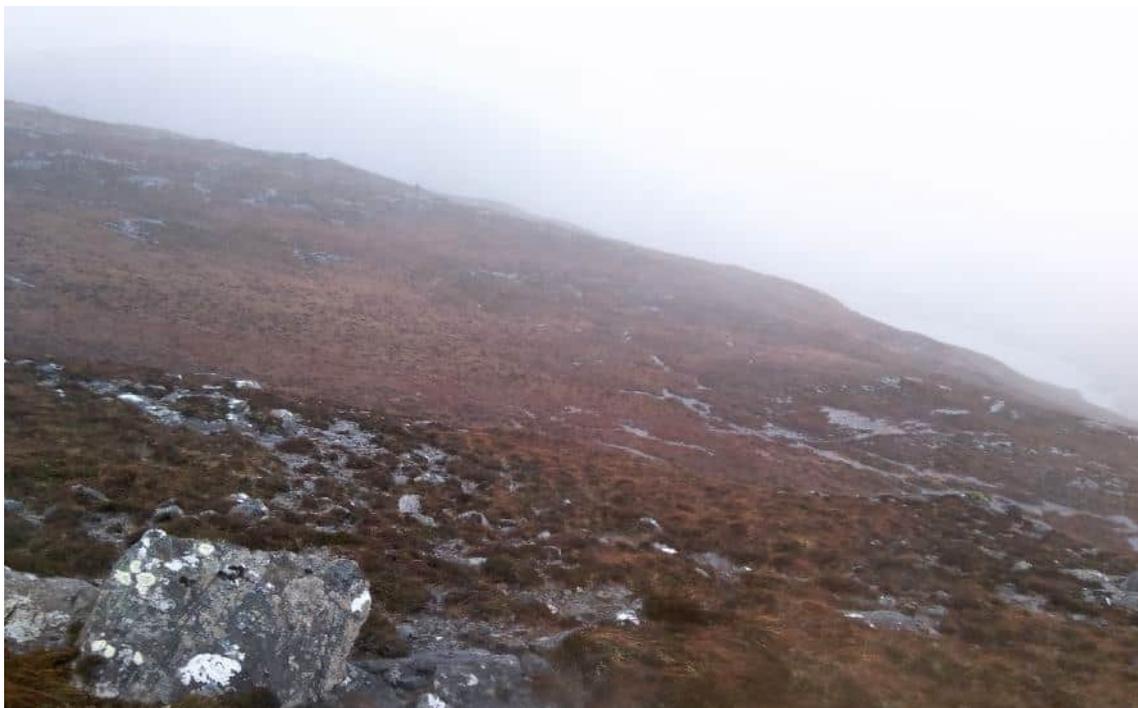
Photo 5: View looking west from NGR NB 30424 11614 showing BP5

Borrow Pit 5 (BP5) is proposed in the south of the Site at approximately NGR NB 30437 11622 shown on **SEI Figure 10.3.8** with further details in **Table G**.

Borrow Pit Details	
Excavation Area	Approximately 12,810m ²
Height of Excavation	Approximately 16.4m
Gradient	Slope increasing gently towards the south
Details of Likely Extraction	Combination of digging, drilling and blasting
Likely Overburden Type and Depth	No detailed GI undertaken to date. No mapped superficial deposits. Average peat depth thickness 0.20m.
Extent of Aggregate Extraction	Approximately 116,519m ³
Aggregate Composition	Outer Hebrides Thrust Zone Mylonites Complex - Pseudotachylite

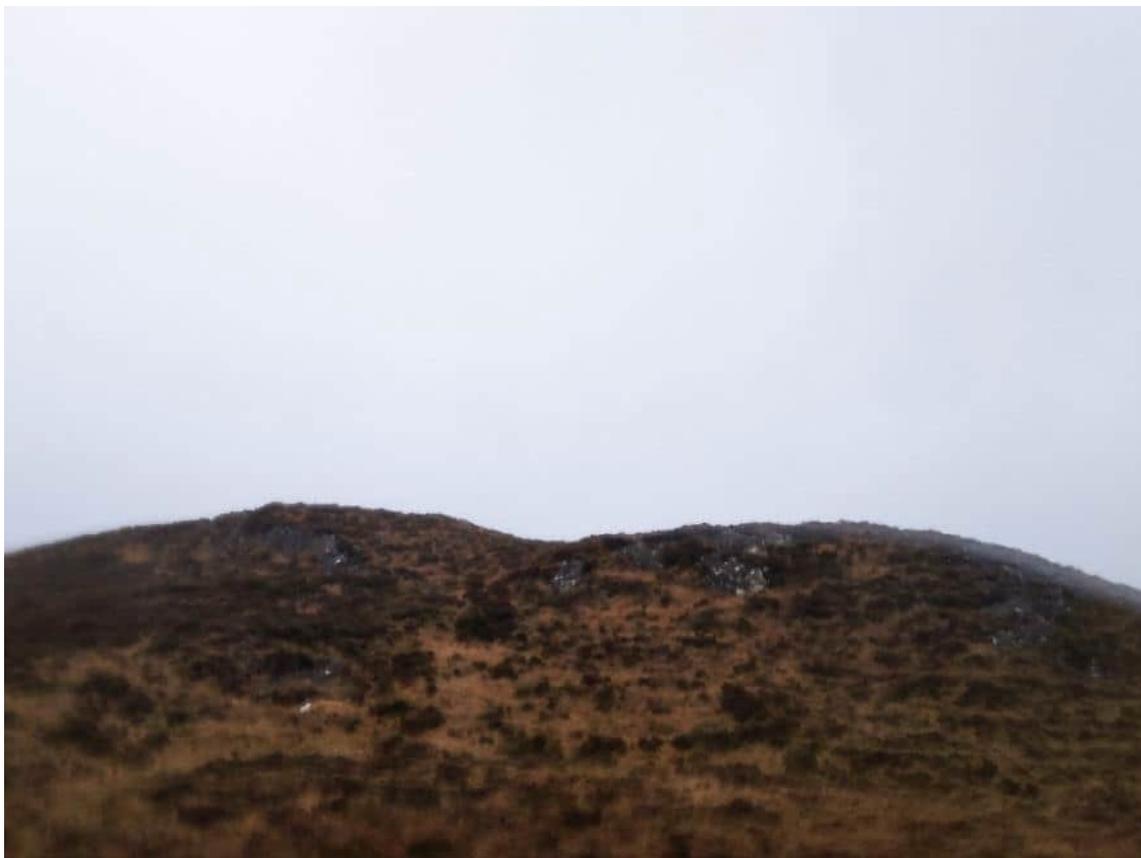
Photo 6: View looking southwest from NGR NB 30630 11836 showing BP6

Borrow Pit 6 (BP6) is proposed in the south of the Site at approximately NGR NB 30586 11787 shown on **SEI Figure 10.3.9** with further details in **Table H**.

Borrow Pit Details	
Excavation Area	Approximately 5,200m ²
Height of Excavation	Approximately 10.3m
Gradient	Slope increasing gently towards the north
Details of Likely Extraction	Combination of digging, drilling and blasting
Likely Overburden Type and Depth	No detailed GI undertaken to date. No mapped superficial deposits. Average peat depth thickness 0.35m.
Extent of Aggregate Extraction	Approximately 32,007m ³
Aggregate Composition	Outer Hebrides Thrust Zone Mylonites Complex - Pseudotachylite

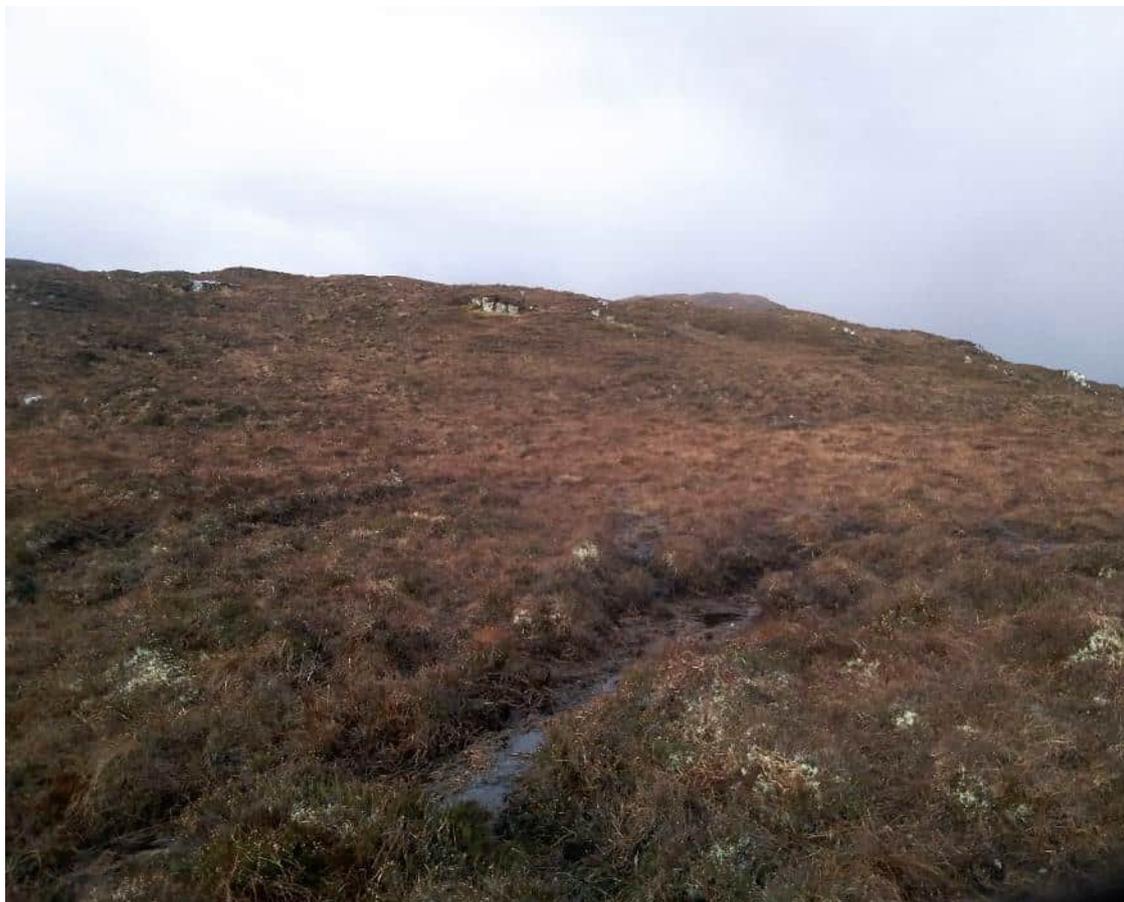
Photo 7: View looking south from NGR NB 31881 15747 showing BP7

Borrow Pit 7 (BP7) is proposed in the north of the Site at approximately NGR 132831, 914332, shown on **SEI Figure 10.3.10** with further details in **Table I**.

Borrow Pit Details	
Excavation Area	Approximately 15,824m ²
Height of Excavation	Approximately 12m
Gradient	Slope increasing gently towards the north
Details of Likely Extraction	Combination of digging, drilling and blasting
Likely Overburden Type and Depth	No detailed GI undertaken to date. No mapped superficial deposits. Average peat depth thickness 0.59m.
Extent of Aggregate Extraction	Approximately 107,982m ³
Aggregate Composition	Outer Hebrides Thrust Zone Mylonites Complex - Pseudotachylite

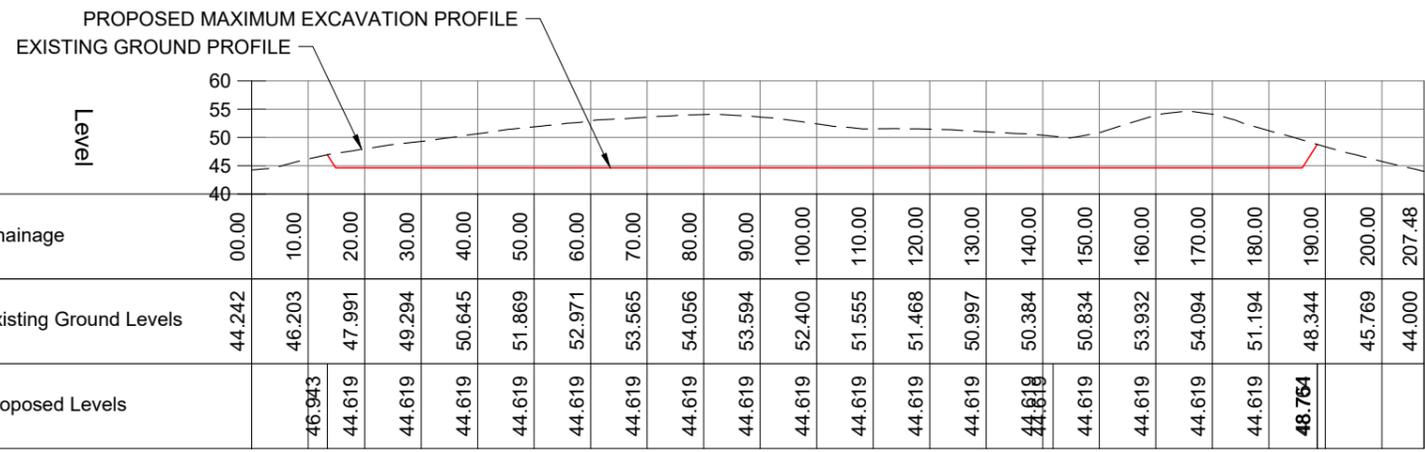
SECTION A
Scale: H 1:1250, V 1:1250. Datum: 40.000

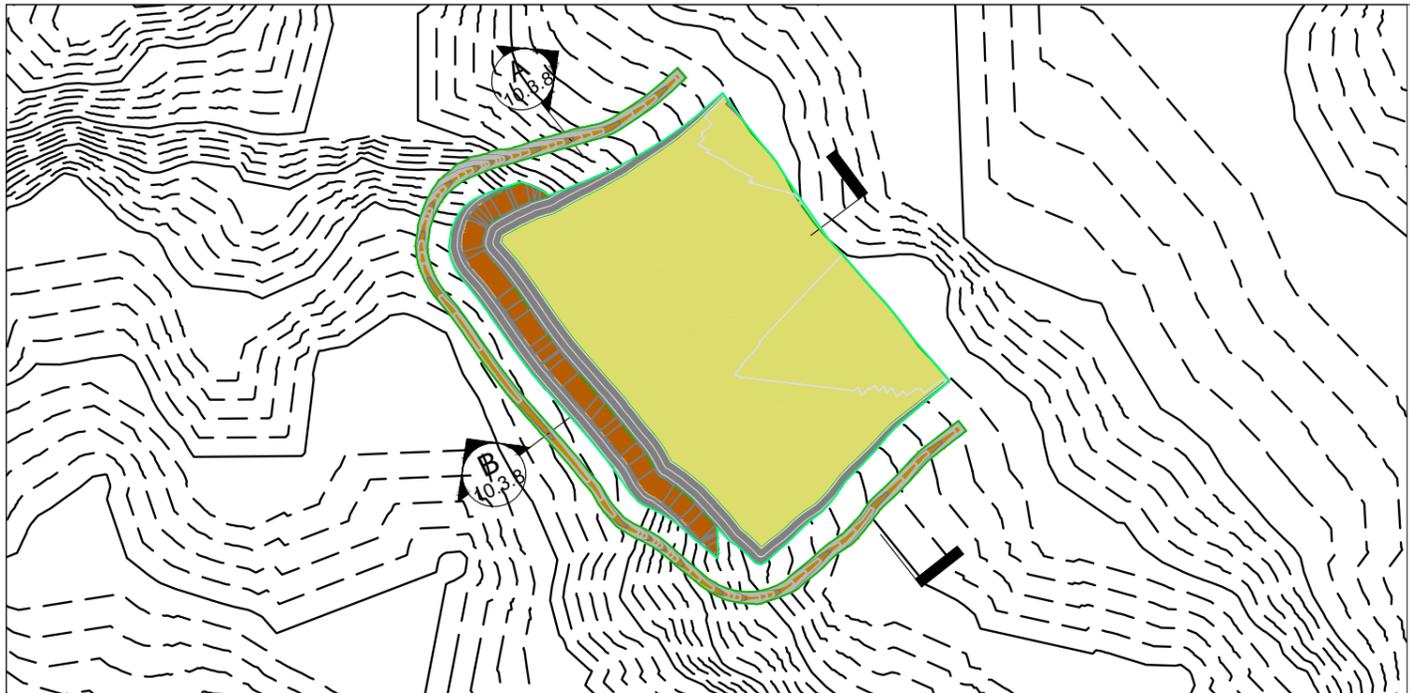
Figure Number
 SEI Figure 10.3.9

01 PLAN OF BORROW PIT
SCALE: 1:2500
