Contents – Technical Appendices

SEI Technical Appendix 3.1: Outline Construction Environmental Management Plan (CEMP)

Uisenis Wind Farm

Uisenis Power Limited

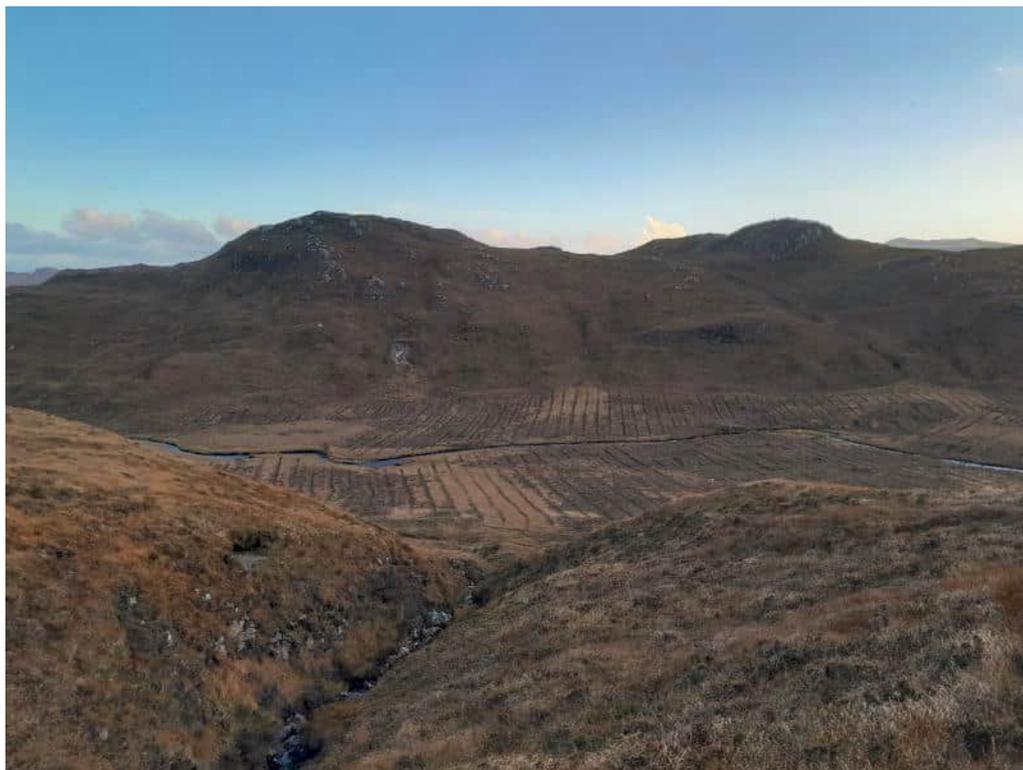
Photo 1: View of drainage channels at the Abhainn Cheothadail (south of river) facing south from NGR NB 30952 12590

Excavated acrotelmic peat could be used for restoration of drainage channels within the peatland restoration areas. The restoration areas are detailed in the **SEI Technical Appendix 8.5 OHMP**, and an example of potentially appropriate drainage channels are provided in **Photo 1** above.

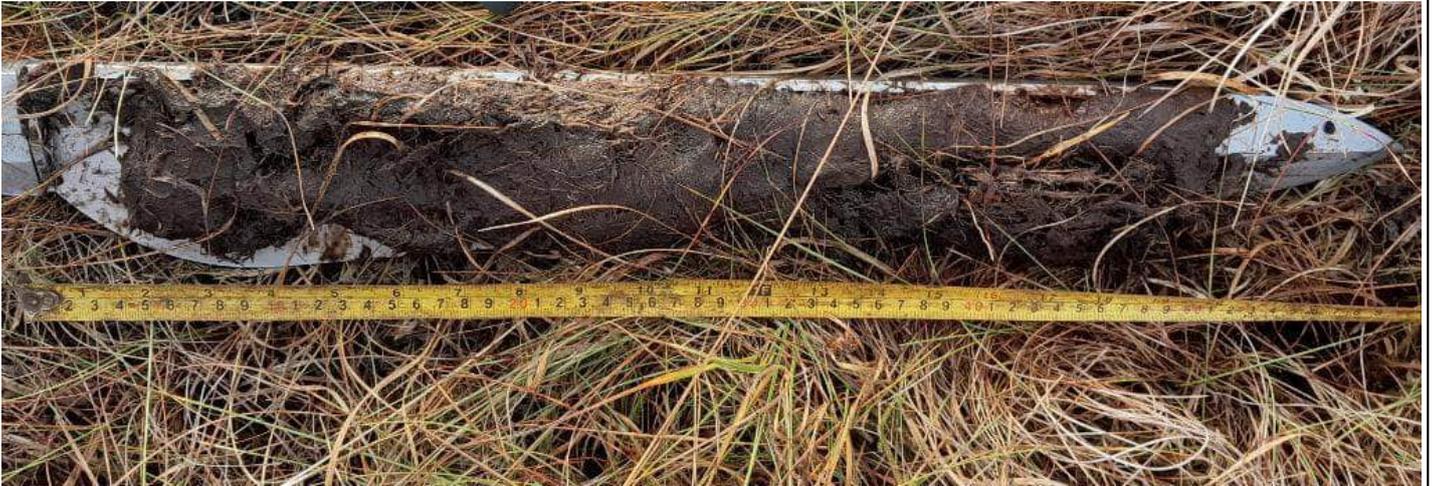
Peat Auger 01
0 – 0.5m

Peat core recovered using peat sampler.
